Belzona Capitalizes on Coalescer

Electrostatic Coalescer.

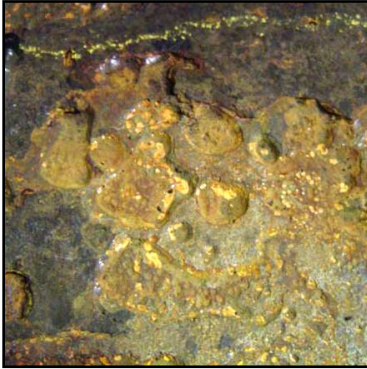
Extent of the corrosion due to the effects of the microbiological attack.

Microbiologically-induced corrosion (MIC) had severely affected portions of this vessel.

As the damage to the vessel was well defined, only the bottom portion of the vessel was treated. Careful surface preparation was implemented as the microbiological impact over the metal was extensive. Detection tests to confirm microorganisms made it a necessity to carefully clean and prepare the metal surface. Ultimately, the Belzona[®] 1121 was used to rebuild the corroded areas, followed by Belzona[®] 5891 as the coating material.

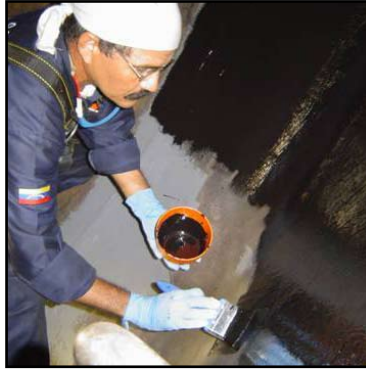
View of the application underway. Belzona[®] 1121 and Belzona[®] 5891 were used.

Belzona[®] 1121
(XL-Metal)
Belzona[®] 5891
(HT Immersion Guide)

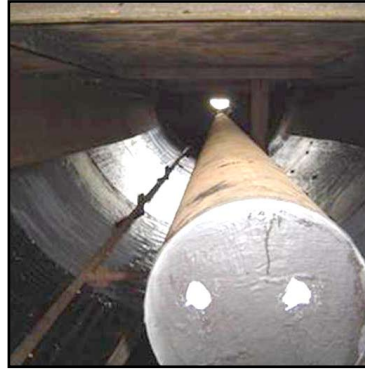
Final view of the entire bottom portion of the vessel that was treated.

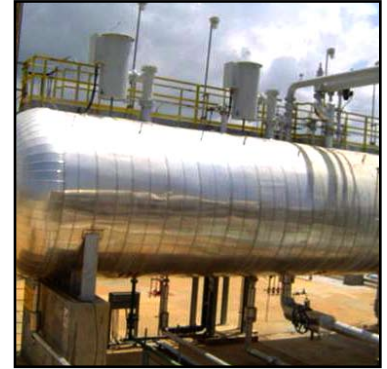
Exterior view of the coalescer.
