Belzona Repaired Pump Lasts Six Time Longer Than a New Pump

316 Stainless Steel Lime Sludge Pump

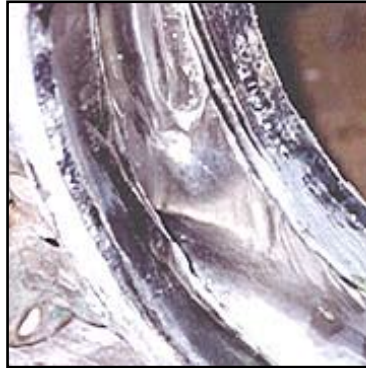
Abraded end suction casing

The pump that transports white liquor impurities over to the mud washer is referred to as the lime sludge pump. The abrasive material was deteriorating the stainless steel and was only lasting six to seven months and costing as much as \$14,000 to replace.

The application was carried out in accordance with Belzona Know-How System Leaflet SHM-13. The actual knives were rebuilt using C-clamps to form the exact shaft of the pocket without machining.

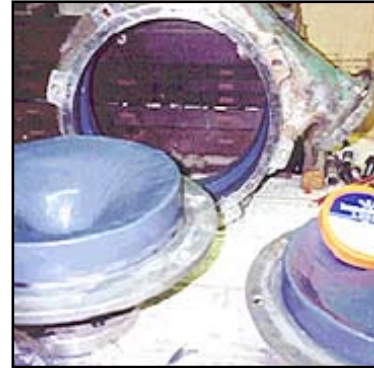
Rebuilt and coated lime sludge pump

The repair usually lasts seven cycles (three to three and one half years), otherwise the \$14,000 pump has to be replaced twice a year.
