## Belzona Elastomer Vs. Sand and Water Abrasion

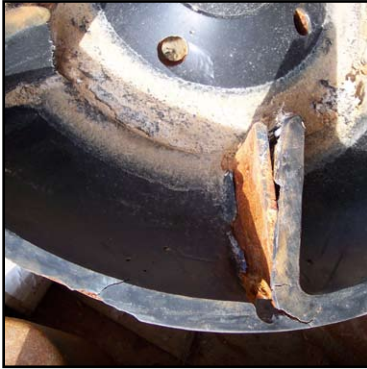
*Typical wear from oil well service caused by sand/water at high pressure*

Pumping HP Sand/water slurry down a well includes a Slinger Disc which is lined with a wear material to counter the abrasion.

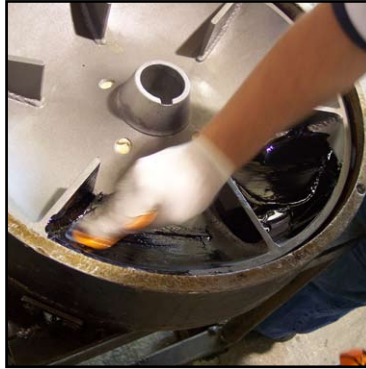
*New prepared slinger being wetted out with Belzona® 2131*

A forming procedure is used to mold the Belzona. After removing from mold and trimming the disc is dynamically balanced. Procedure follows a modified Belzona Know-How System SHM-9

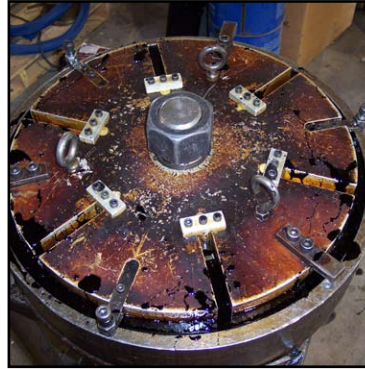
*Mold fitted and filled, waiting cure*

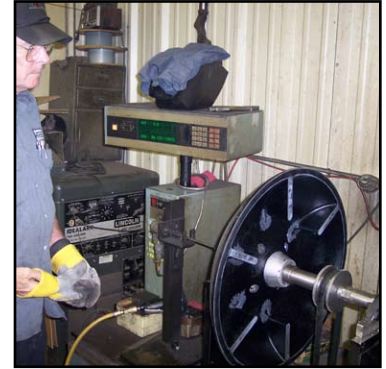
*Final step - spin balancing*
