Belzona Saves Retirement Residence Over \$7,000

Rooftop exhaust fan shroud.

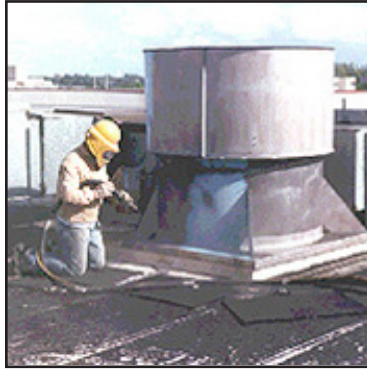
Shroud grit blasted

A six foot diameter exhaust fan is used in case of a fire to evacuate smoke from the burning building. The corroded metal shroud developed holes. Rainwater entered through the holes and caused water damage to the inside of the building.

The application was carried out in accordance with a Belzona Know-How System Leaflets FBC-2 and -4.

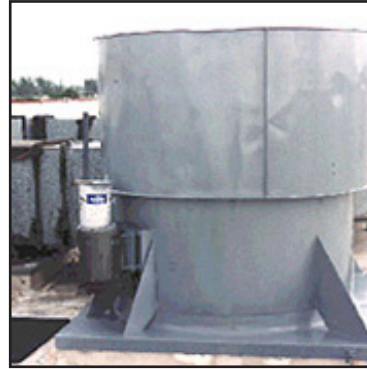
*Completed coating with
Belzona® 5111 (Ceramic Cladding)*

The cost of a new stainless steel shroud was \$9600. The existing shroud was salvaged with approximately \$600 in products. Including blasting, the customer saved over \$7000.
