Belzona Repairs and Improves Francis Turbine Runner

Hydroelectric power plant,
Czech Republic

Francis Turbine Runner.

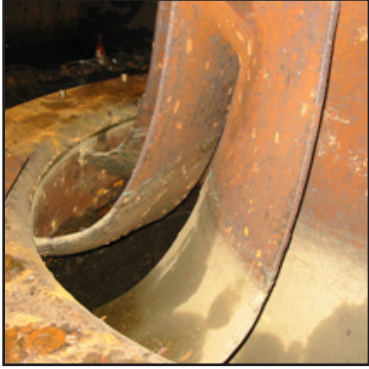
Damaged and worn runner

The runner had suffered extensive damage from erosion, corrosion and mechanical damage.

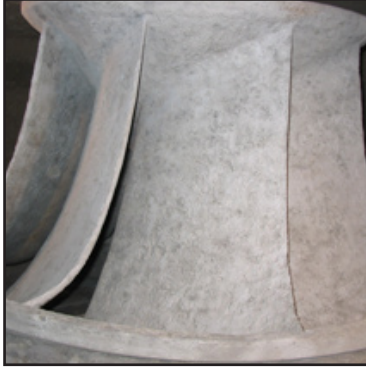
After grit blasting

The application was carried out in accordance with Belzona® Know-How System Leaflets CEP-8 & -10.

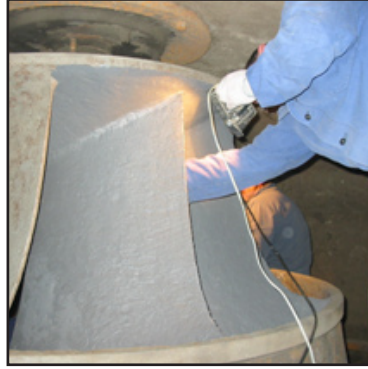
Rebuilding with Belzona® 1111
