## Belzona Protects Mixing Tank

Dairy,  
Oklahoma, USA

Customer needed protection on their  $KMnO_4$  (Potassium Permanganate) mixing tank.

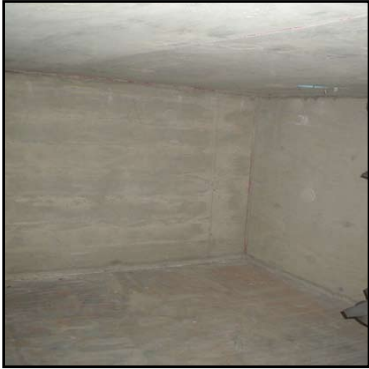
*Bare unprotected mixing tank*
